Learning from experience

A near miss involving pitching a marquee near a high-voltage underground cable

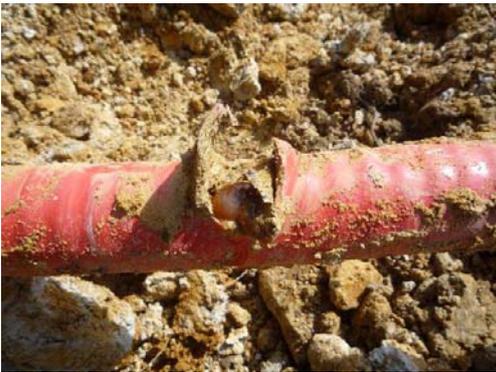
The contractors drove a tent peg through the high-voltage underground cable. It damaged the cable insulation, but did not break/touch the main core of the cable. The power didn't fail immediately, but went off at 6am, one day after the pitching operation, when water in the ground shorted out the power. The contractors did not know they had struck the cable.

Damage to insulation cable by tent peg or spike

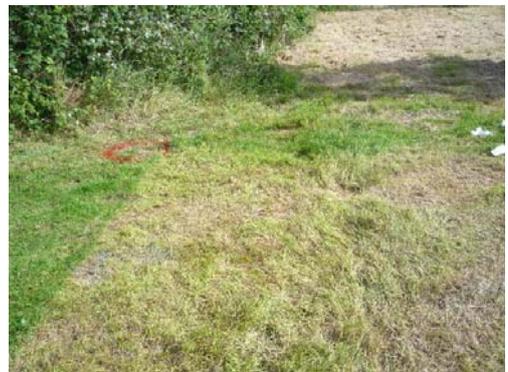
Location of spike hole in the ground

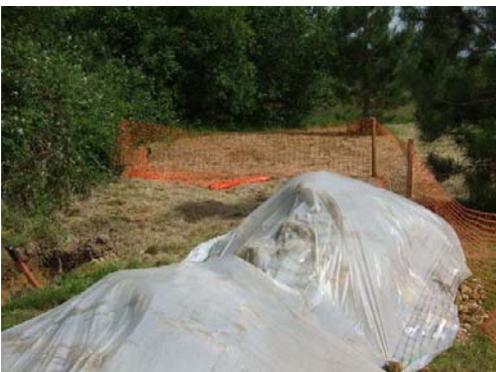
Exploratory dig site to locate damaged cable and repair it

Temporary power was routed to the site to supply the various buildings and facilities. It wasn't until the event was over and all the equipment was removed that the reason for the power failure was discovered.
